# Two unusual incidents - When fire did not become a conflagration, and when it did so

Budapest - Százhalombatta 18. November 2009  
Jozef Lauko, Chief of Fire Brigade

Rim Seal fire  
on storage  
tank  
N 61201A  
6 June 2007

**Conflagration transformer T 108 at Head  
transformer station No.2  
13.8.2008**

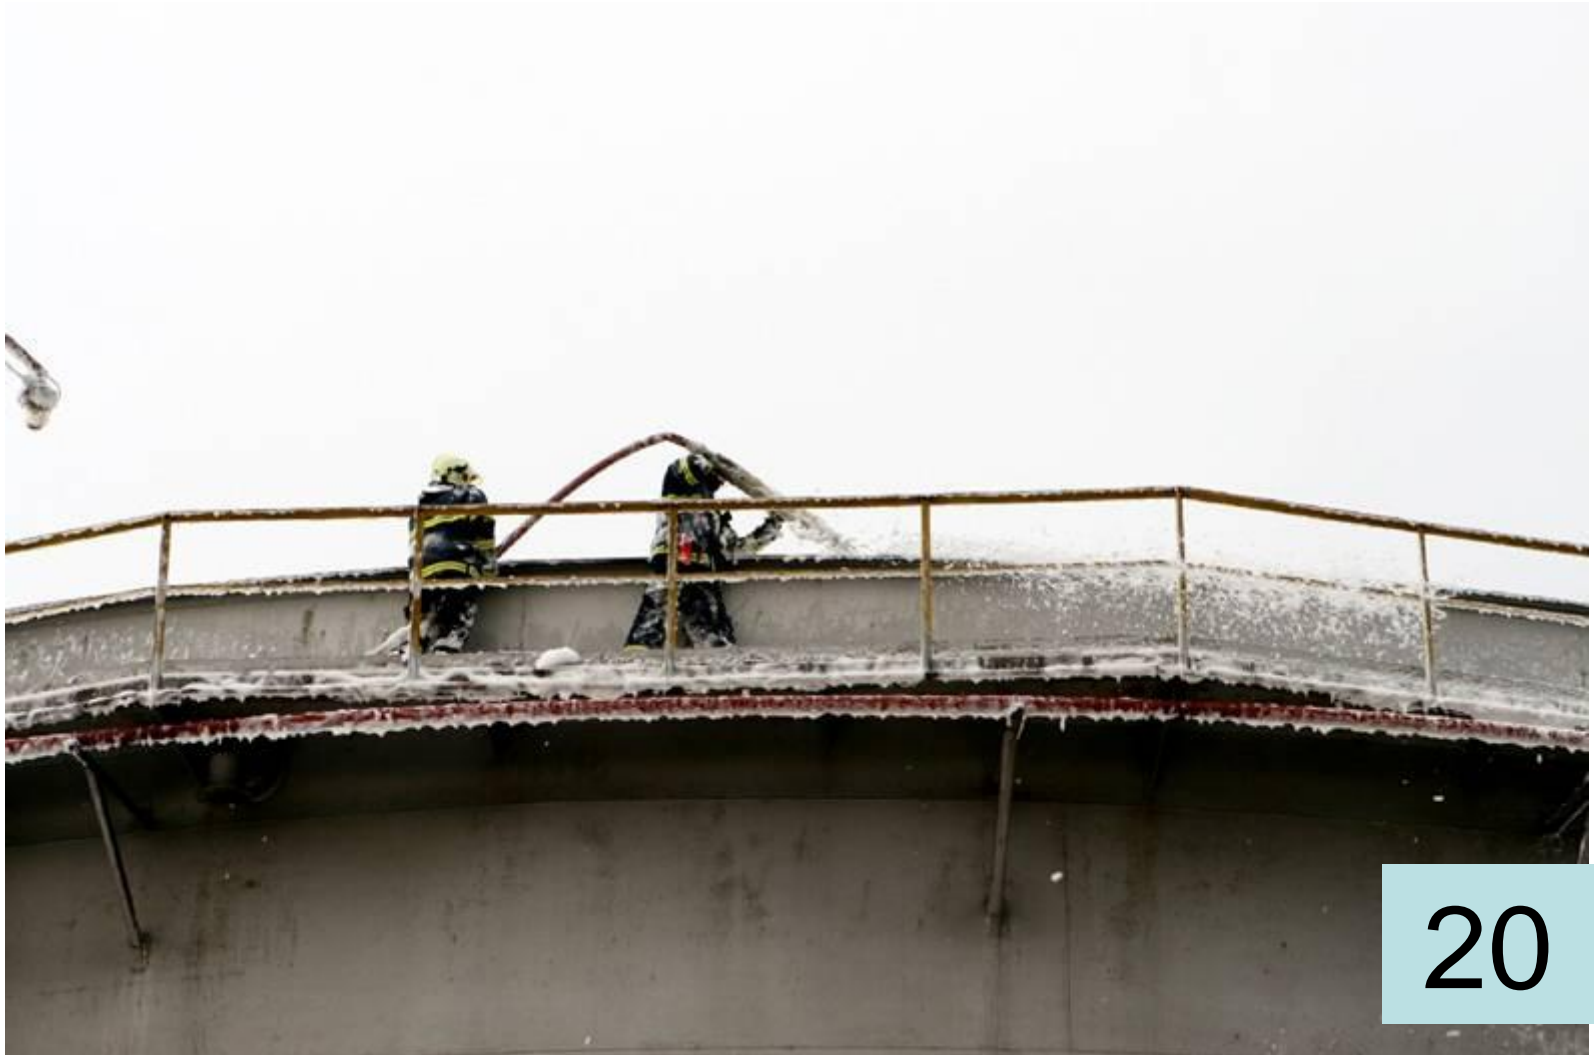
# Progressive extinguishment of the fire from east to the north

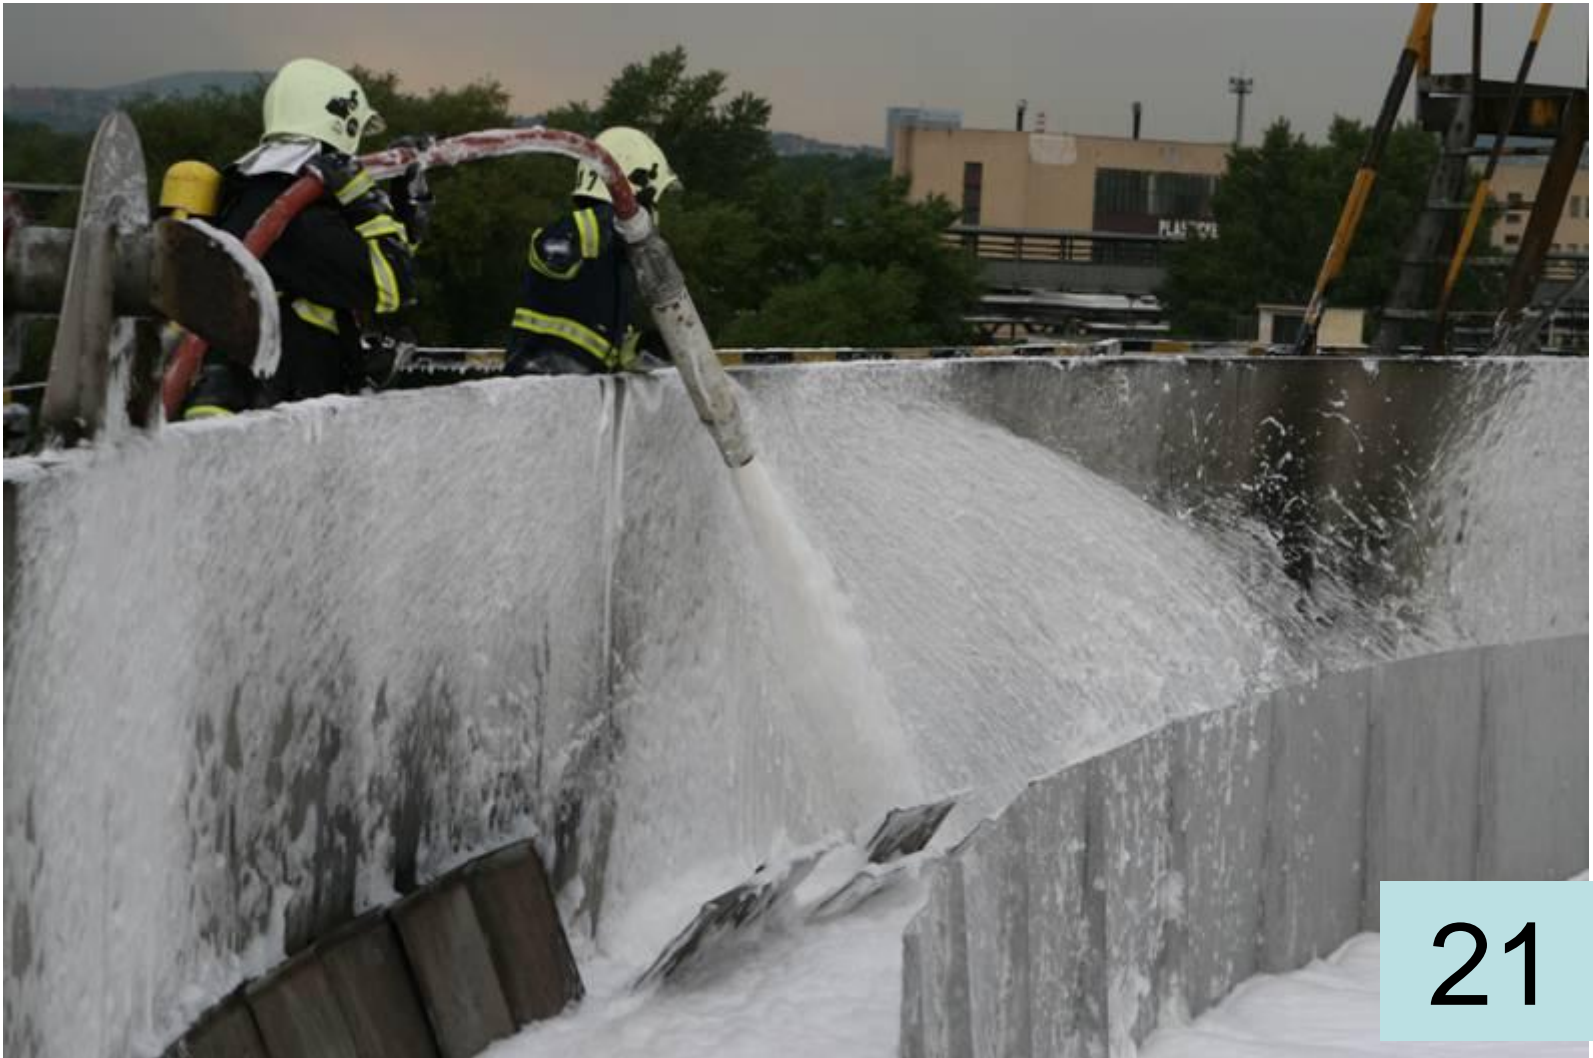
# Progressive extinguishment of the fire from west to the north

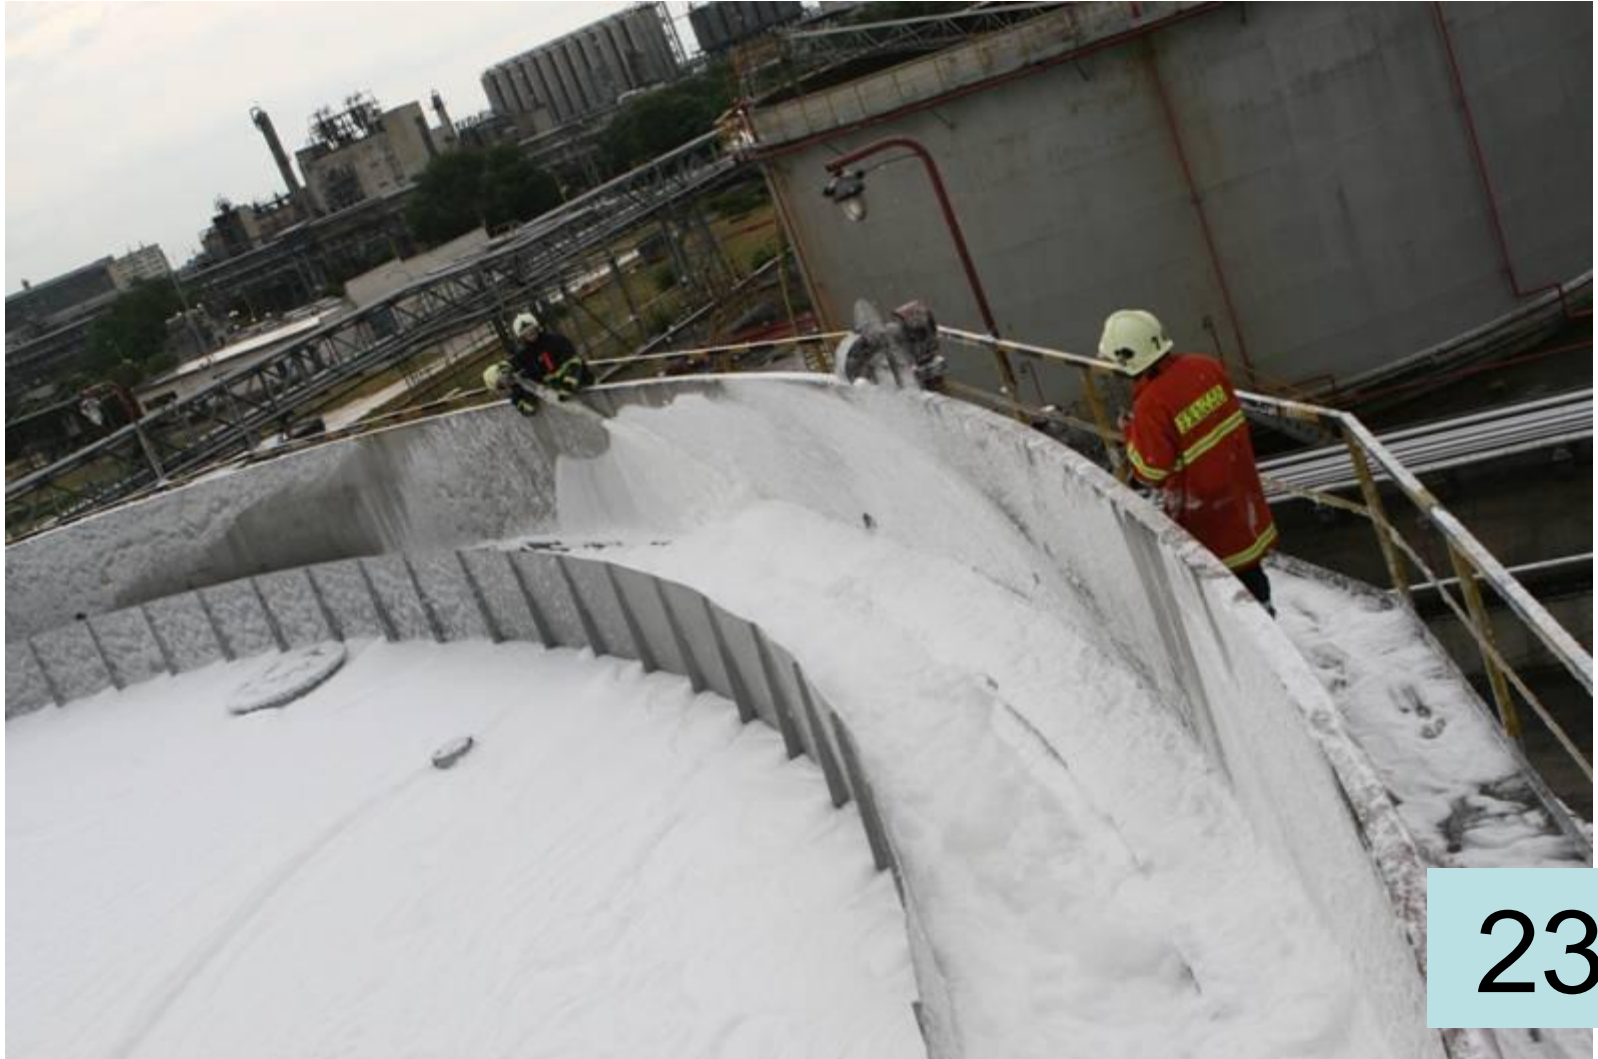
Officer – in - charge checks foaming focal spot of fire on the west side of tank

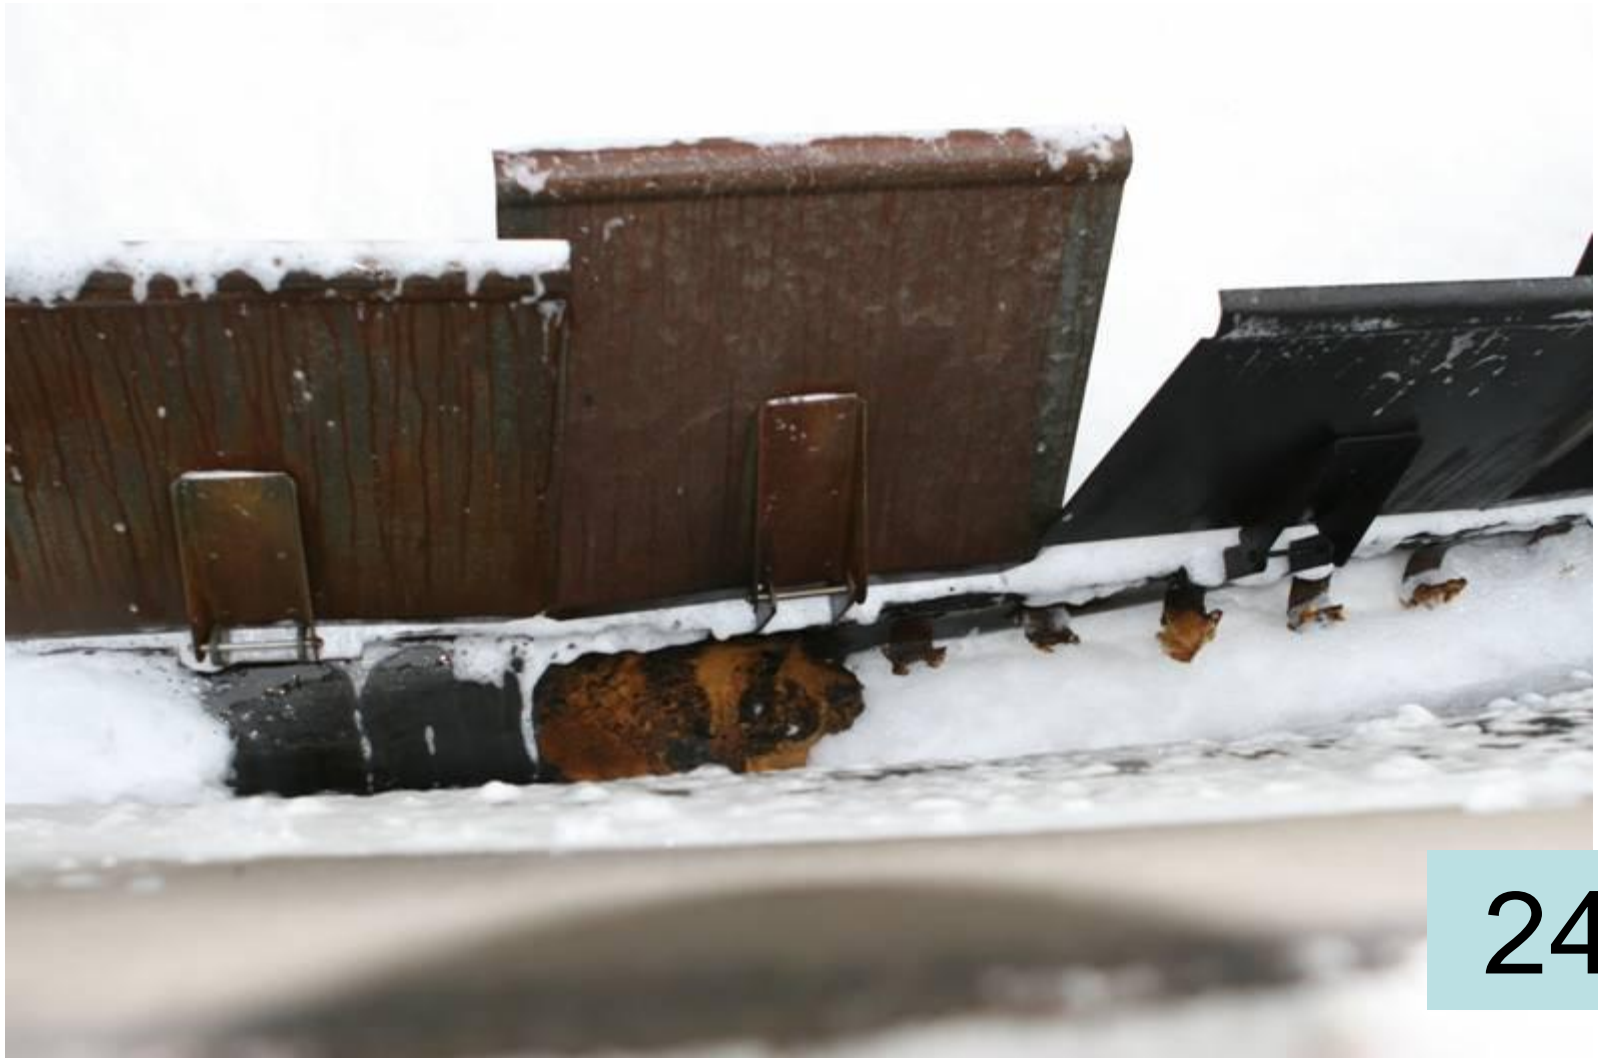
The edge of focal point – at the left side is rubber sealing – at the right a naked petrol level

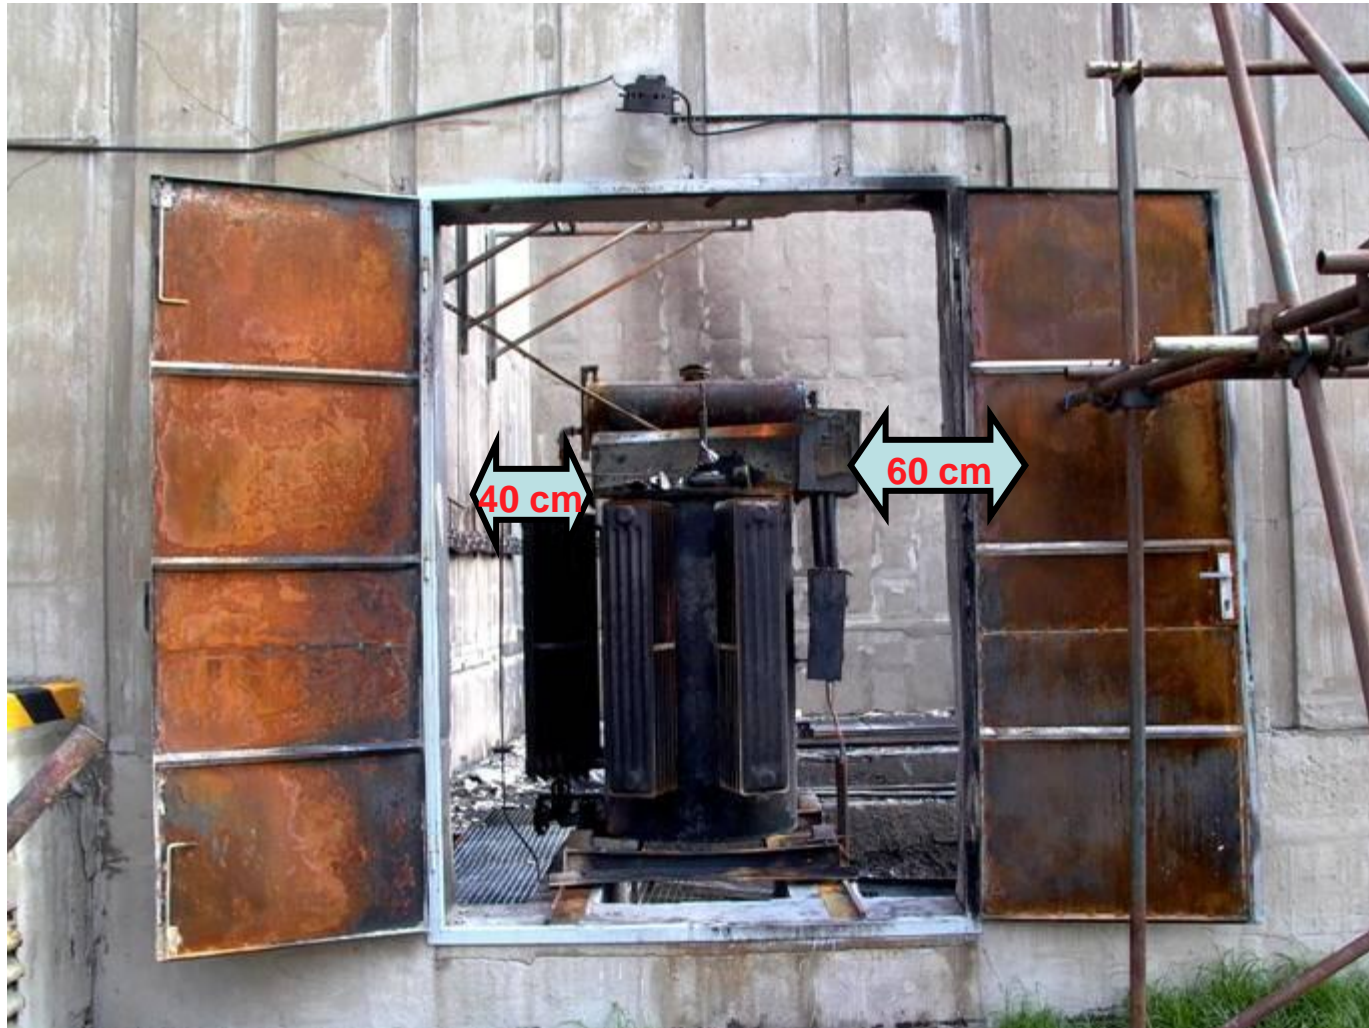
A system mistake which makes the intervention more complicated

- In partnership with experts (electricians) it is necessary to develop principles of extinguishing transformers
- To the space of transformers to install semi - fixed equipment
- To create more access places to the area of transformer
