# MOL Plc's PB emergency transloading unit

8<sup>th</sup> International Conference for Fire Brigades in the High Hazard Industry

# Case study of Miskolc' railway tanker incident

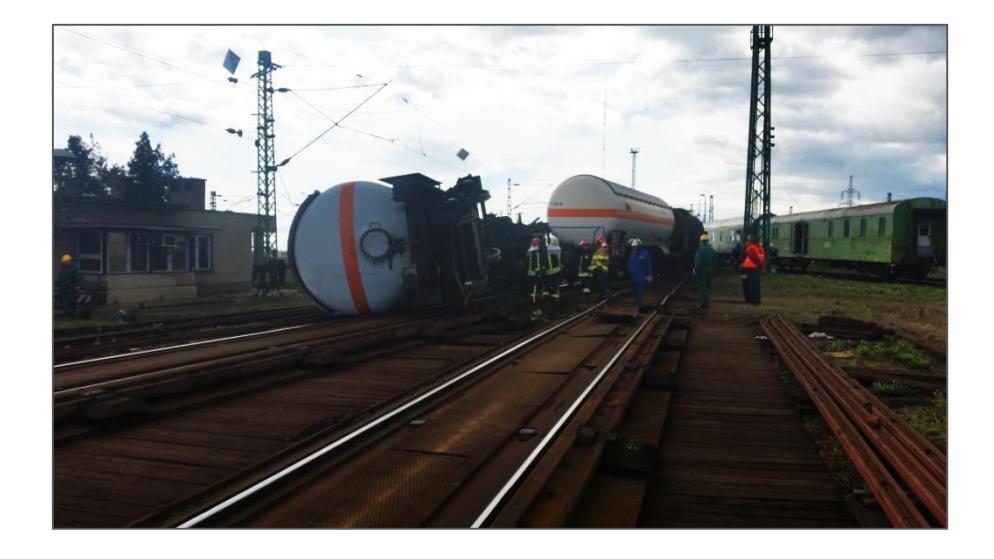
During sorting the RTCs, due to a failed switching, 1 RTC derailed and turned over, 2 other RTCs also derailed, and hit the first one.
 No leakages, no personal injuries!

- The RTC's mantle is far too weak to bear the weight of a fully loaded LPG tank while being recovered.
- As a result the turned-over RTC has to be emptied first.

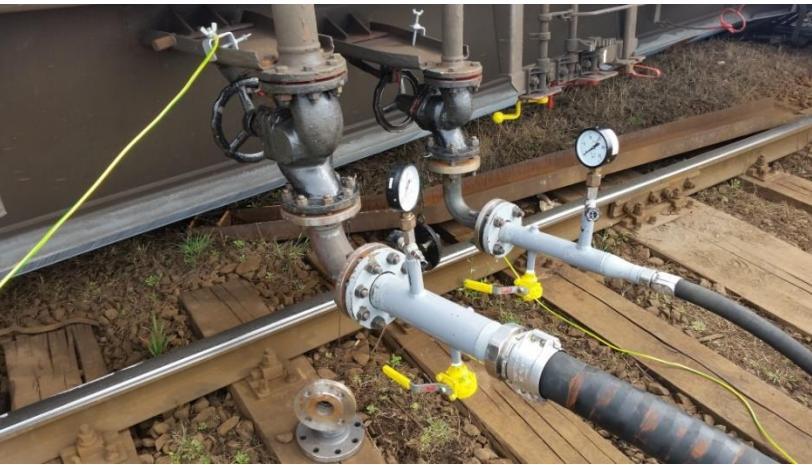
There was not enough room to fit the transloading hoses, so two 90<sup>o</sup> elbows were manufactured.
