# LI-ION AKKUMULÁTOROK GYÁRTÁSA

# LÍTIUM ION AKKUMULÁTOROKRÓL ÁLTALÁBAN

# KIÉRTÉKELŐEGYSÉG

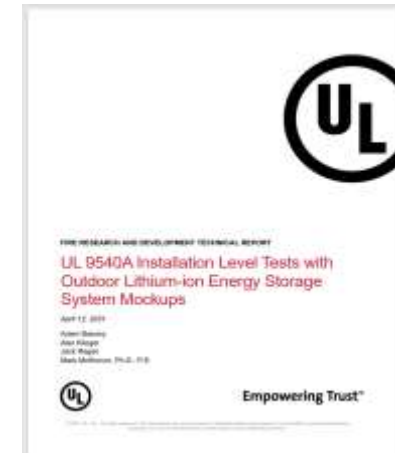
- Venting at 21 minutes & 37sec.
- TR at 29 minutes & 53sec.
- **Early Warning: 8 minutes & 16 seconds**
- **UL Findings:**
  - All gas detectors alarmed 30 seconds after TR
  - Smoke detectors alarms 60 seconds after TR
  - Propagation occurred after 8 min & 49 seconds

- UL very clearly states that traditional detectors are not capable of detecting gas/smoke before TR
- H2, CO, LEL and smoke only alarm only after TR occurs

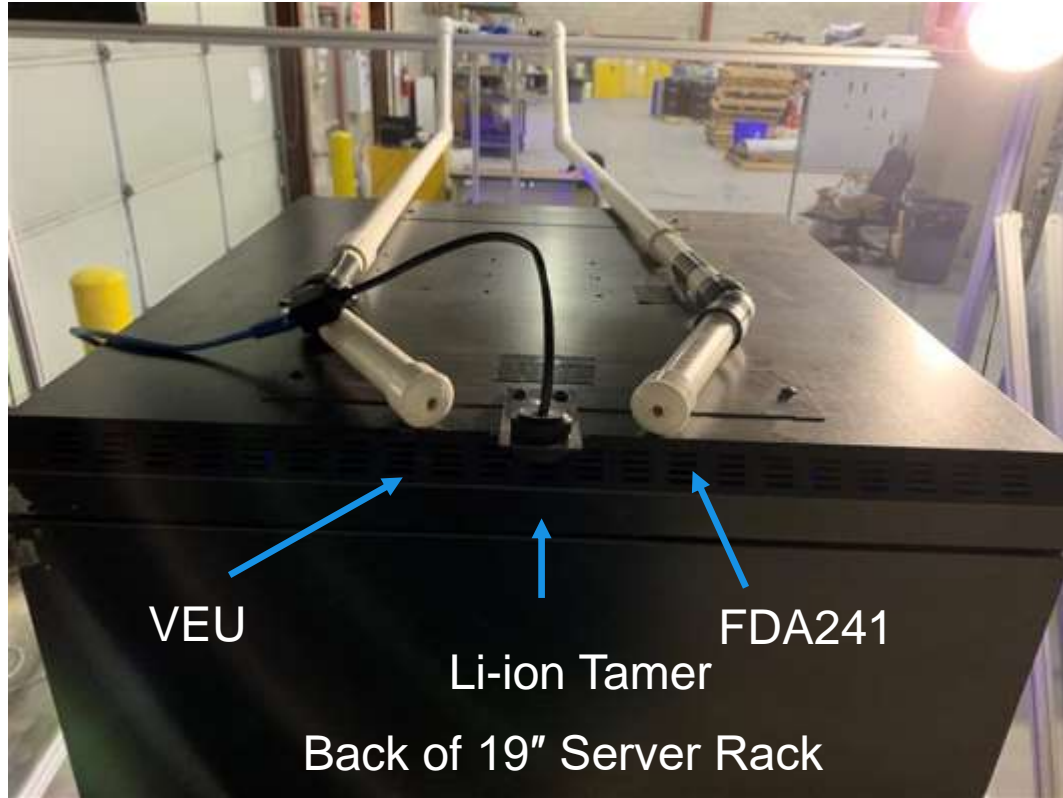
Setup A: Battery Abuse by Over-Heating in a Battery Rack

- ASDs comprised 10m pipe with single hole sampling (no clean air dilution)
- XCL gas detectors installed in-line with VEU pipe
- Setup A: comprised front-to-back rack airflow, Setup B: sampling located downstream of abuse battery (i.e. vent size of the room)

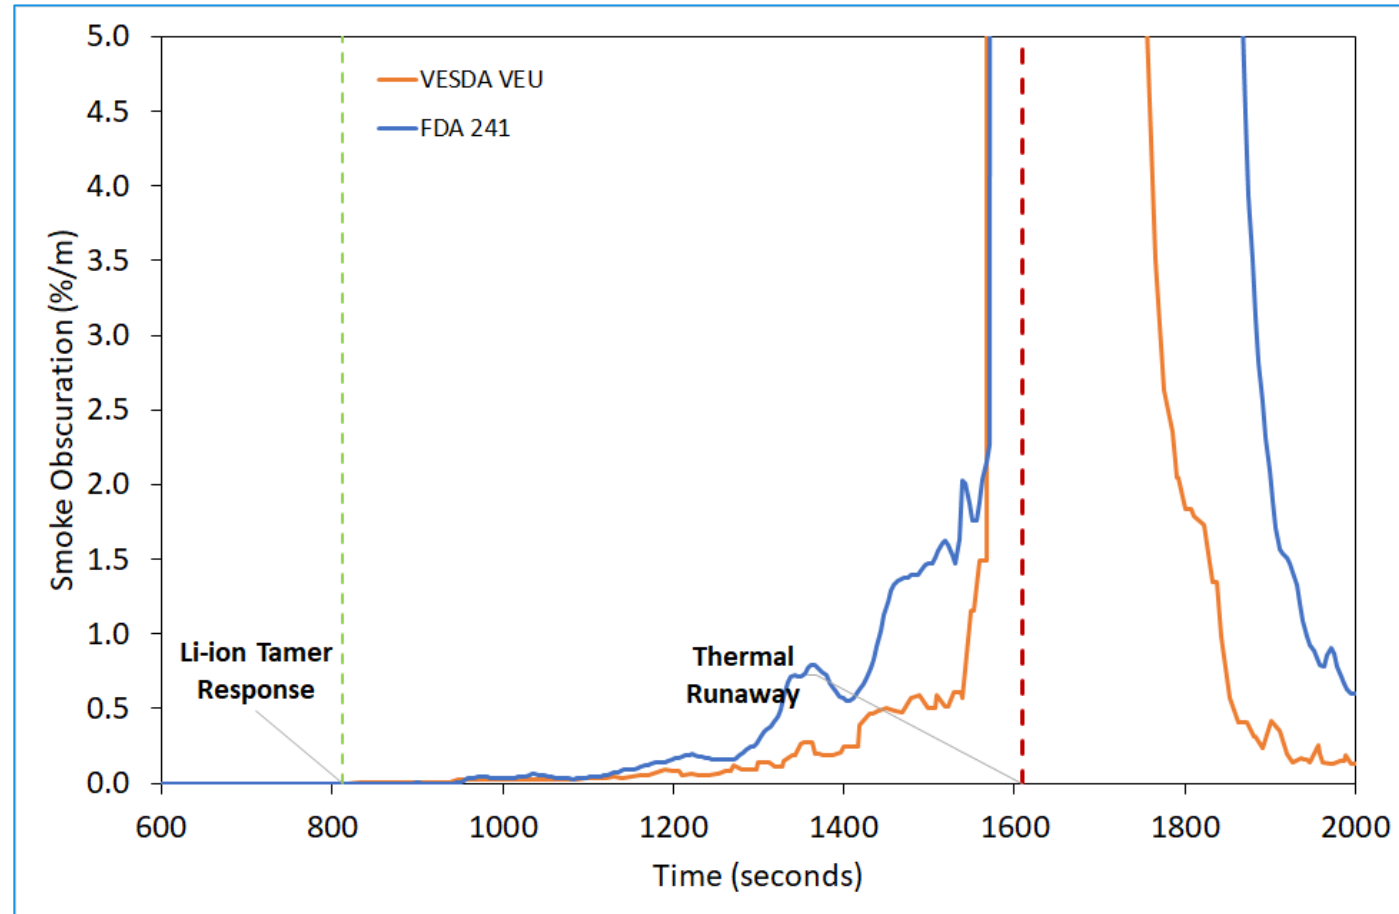
- Beltér
- Gáz érzékelés
- Füst érzékelés
- Túltöltés

Both Li-ion Tamer and ASDs responded before Thermal Runaway with Li-ion Tamer providing earlier notification.

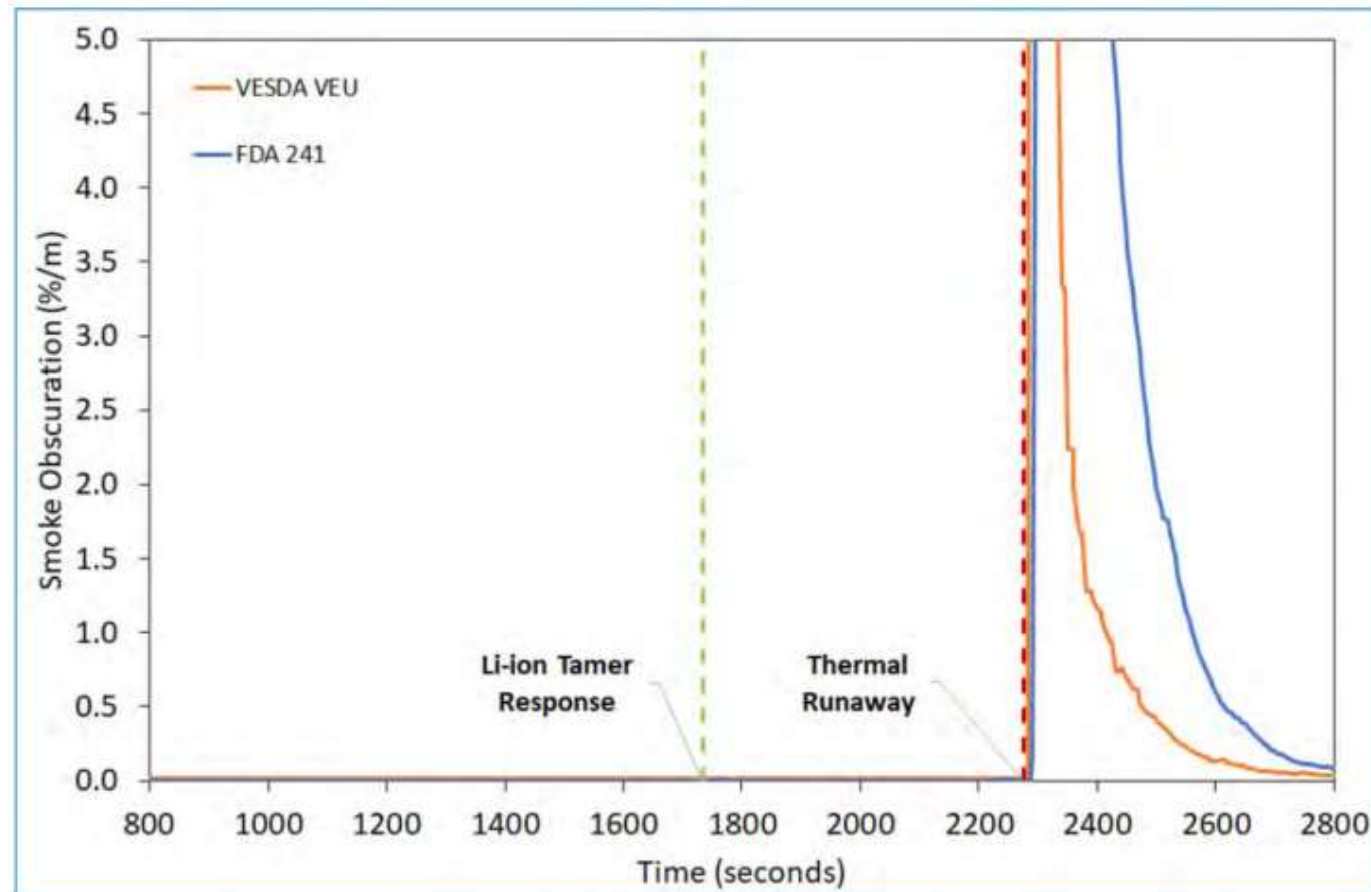
- Beltér
- Gáz érzékelés
- Füst érzékelés
- Túlhevítés

There were no responses from any of the ASD detectors during the off-gas event or prior to thermal runaway.

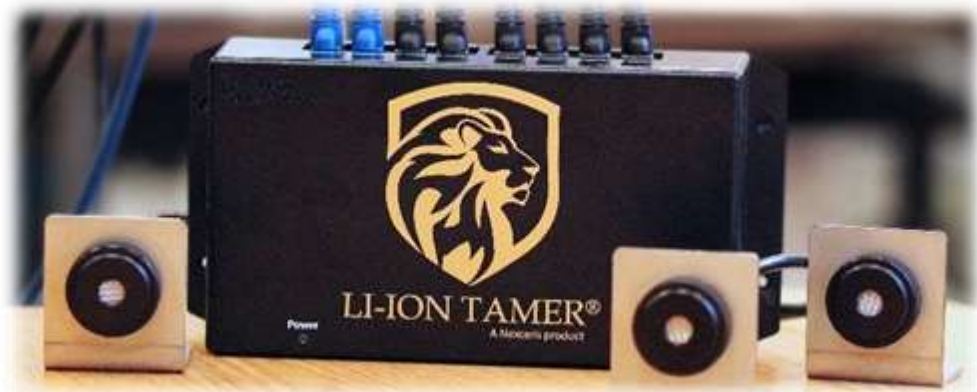
12 érzékelő szenzor illesztéséhez alkalmas kiértékelőegység

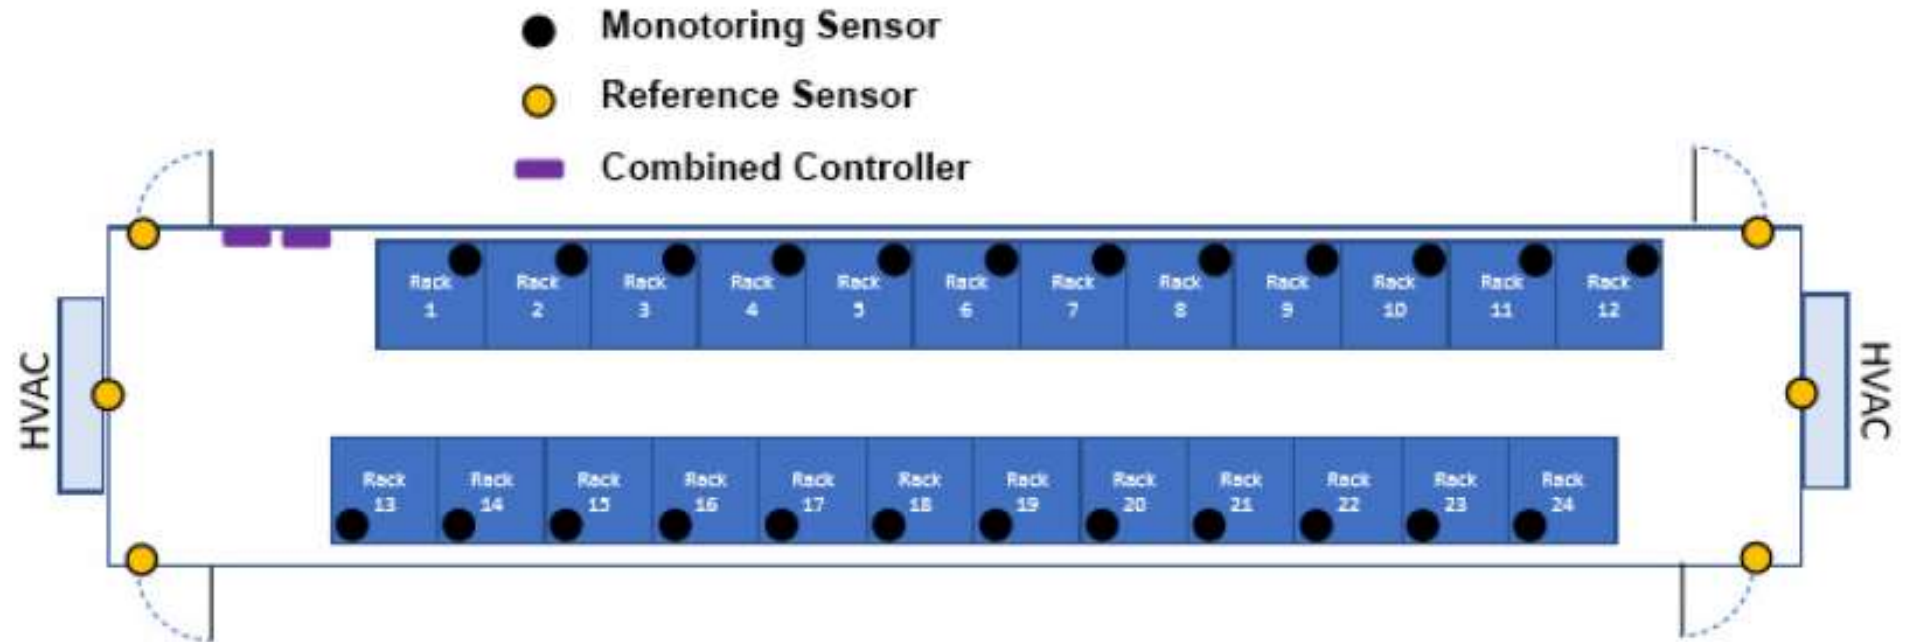
# LI-ION TAMER TELEPÍTÉSE EGY 40 LÁBAS KONTÉNERBE

Note that there are a total of twenty-four (24) Monitoring Sensors and six (6) Reference Sensors that are aggregated by two (2) Combined Controllers.
